Inelastic Deformation of Metal Matrix Composites

Part I—Plasticity and Damage Mechanisms

B.S. Majumdar and G.M. Newaz
Battelle Memorial Institute
Columbus, Ohio

INELASTIC DEFORMATION OF METAL MATRIX COMPOSITES: PLASTICITY AND DAMAGE MECHANISMS

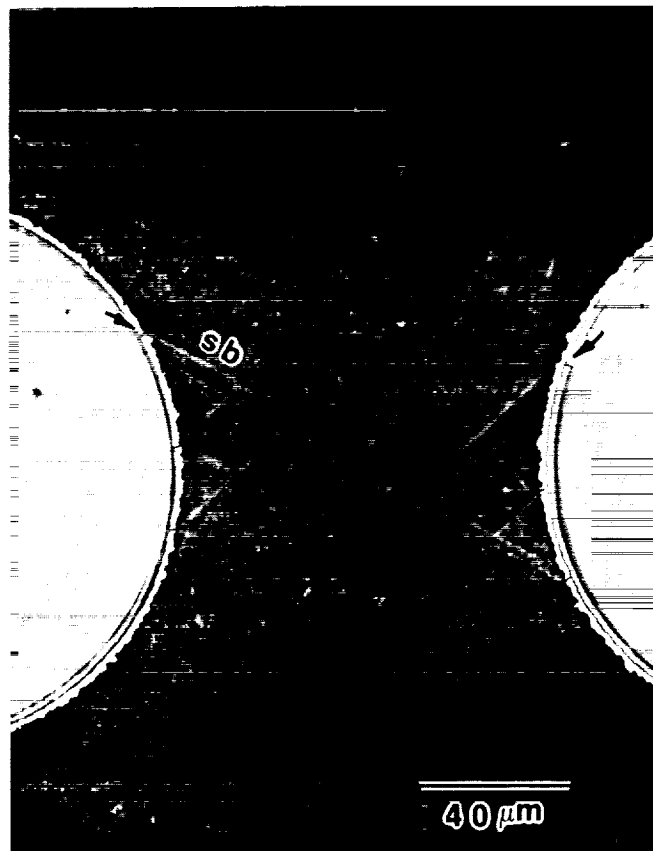
Figure 25. Optical photomicrograph of a 90-degree specimen, unloaded from a strain of 0.5 percent (Stage II). The slip bands (white lines) are mostly associated with reaction-zone cracks; the latter, although faint in this figure, are indicated by arrows.

- Figure 25. Optical photomicrograph of a 90-degree specimen, unloaded from a strain of 0.5 percent (Stage II). The slip bands (white lines) are mostly associated with reaction-zone cracks; the latter, although faint in this figure, are indicated by arrows. Loading axis is vertical.
